**NAVAL
POSTGRADUATE
SCHOOL**

THESIS

**ANALYSIS OF THE FAILURE OF A VACUUM SPIN-PIT
DRIVE TURBINE SPINDLE SHAFT**

September 2005

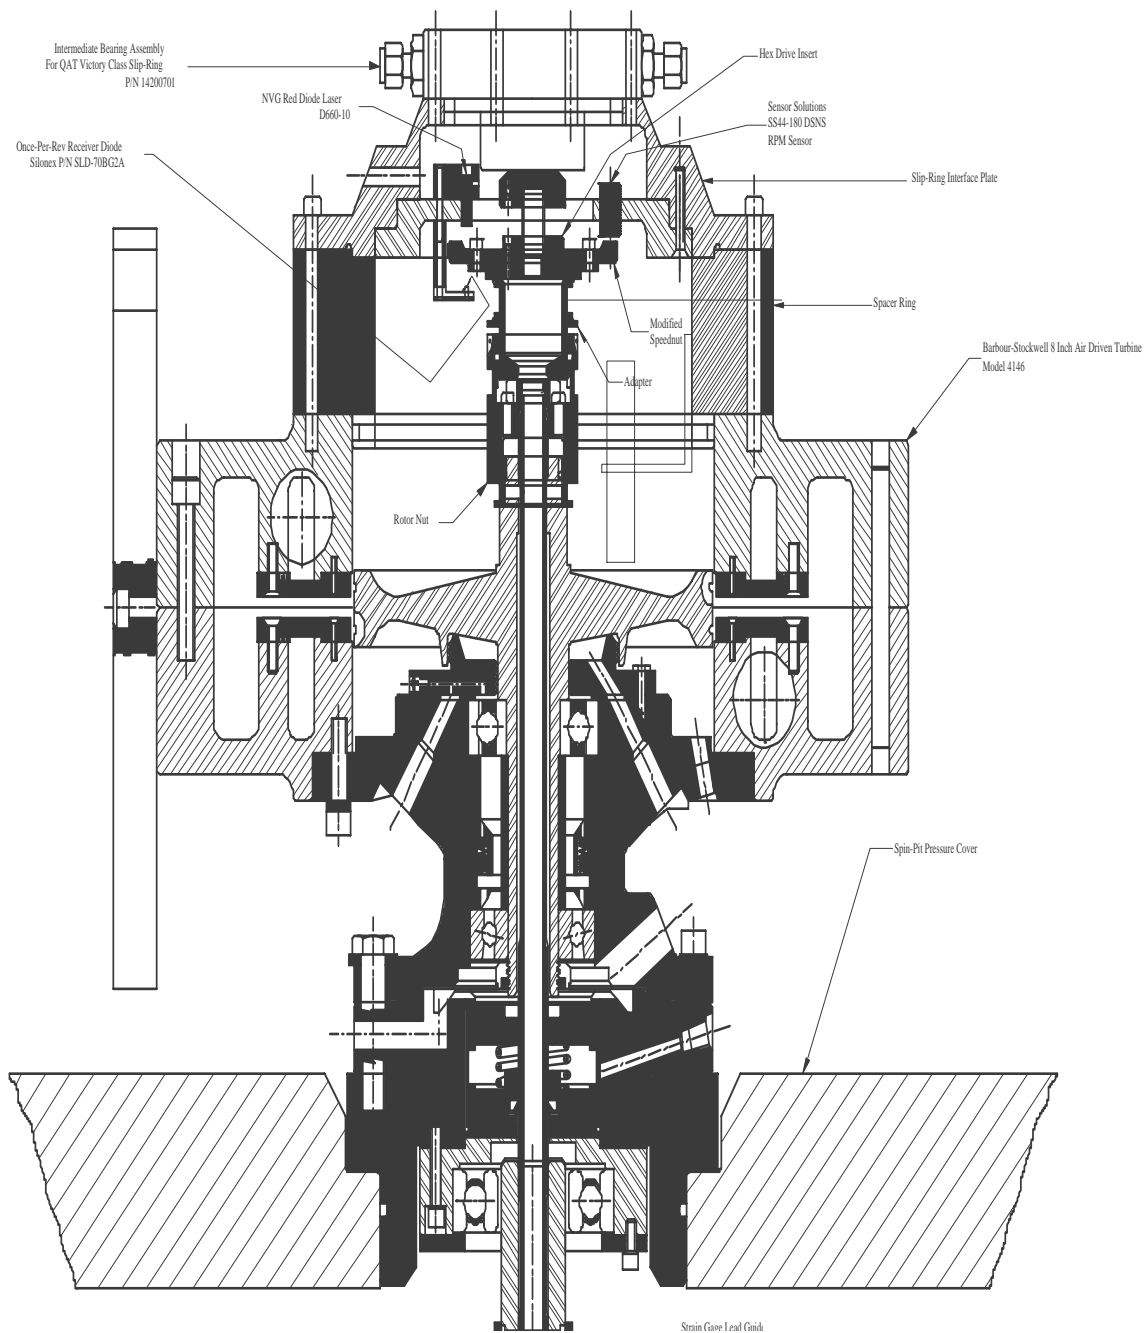
Figure 2. Turbine and Shaft Assembly

Figure 2 shows the turbine assembly and its complexity. At the time of the failure, the turbine was connected to the rotor test article by a hollow spindle shaft. The shaft was 14.775" in length, and had an outer diameter of 0.625" and an inner diameter of 0.400". The shaft was suspended on a button resting on a horizontal surface in the air turbine and was secured by a threaded nut.

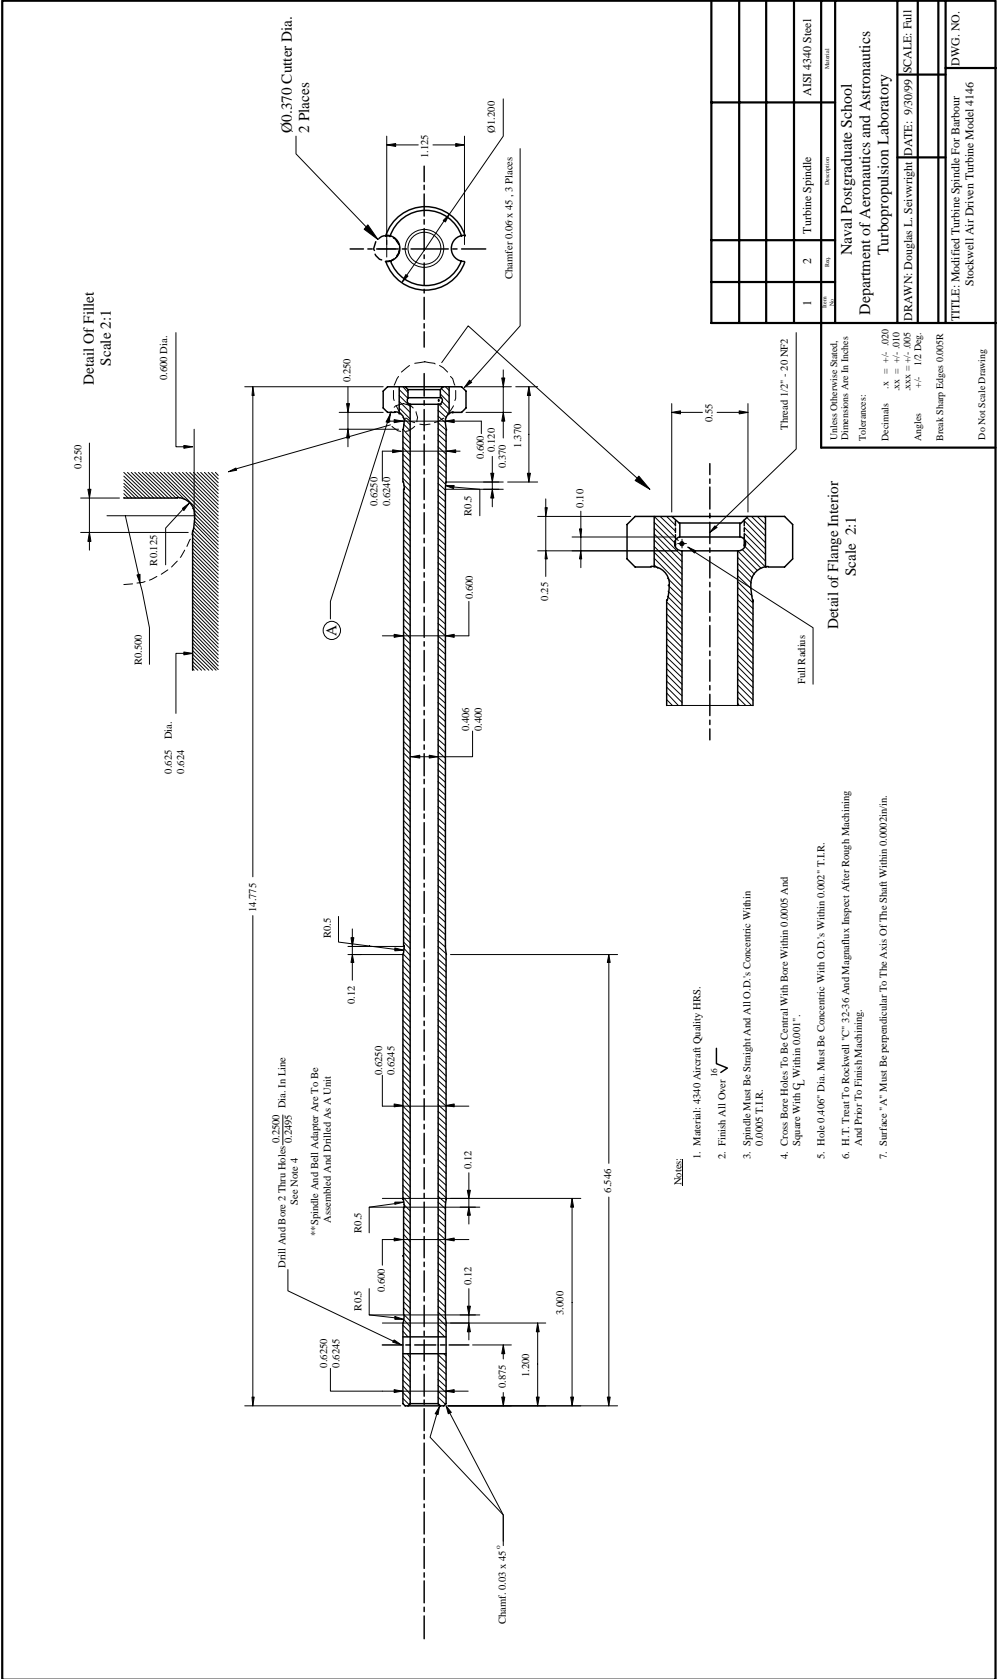
Figure 3. Design Drawing of the Spindle Drive Shaft

Figure 3 shows the design drawing for the spindle drive shaft, and Figure 4 shows how the shaft was connected to the adapter, collar and arbor. The test rotor was attached to the flange at the bottom of the arbor. The

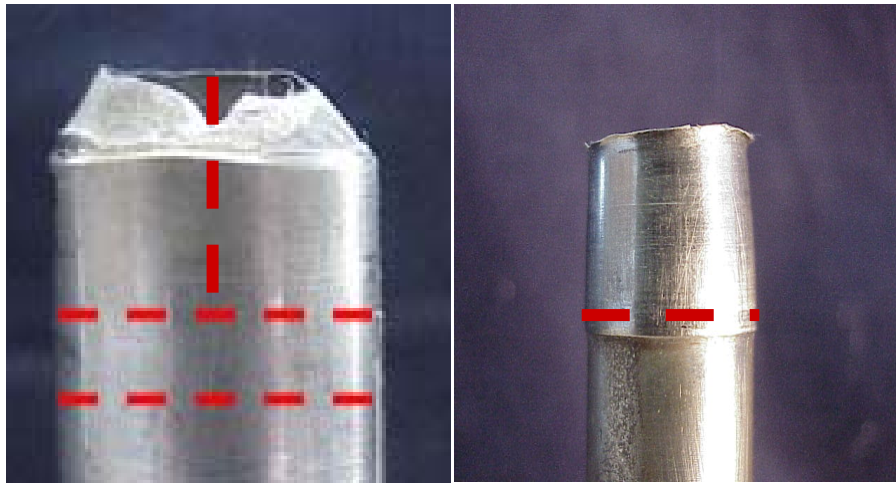
Figure 14. Sectioning of Spindle Shaft

After removing the spindle shaft from the spin pit and performing a thorough visual inspection of the fracture site, the specimen was cross-sectioned twice and the resulting pieces were prepared for further analysis. The

complete lower spindle fracture surface was set aside for Scanning Electron Microscopy (SEM) Analysis. The upper spindle fracture surface was cut into two pieces in the axial direction, mounted, polished and etched with a Nital solution, for examination under the optical microscope. A "donut" cross-section was also taken from the shaft in order to conduct hardness testing of the material. This is shown in Figure 14.

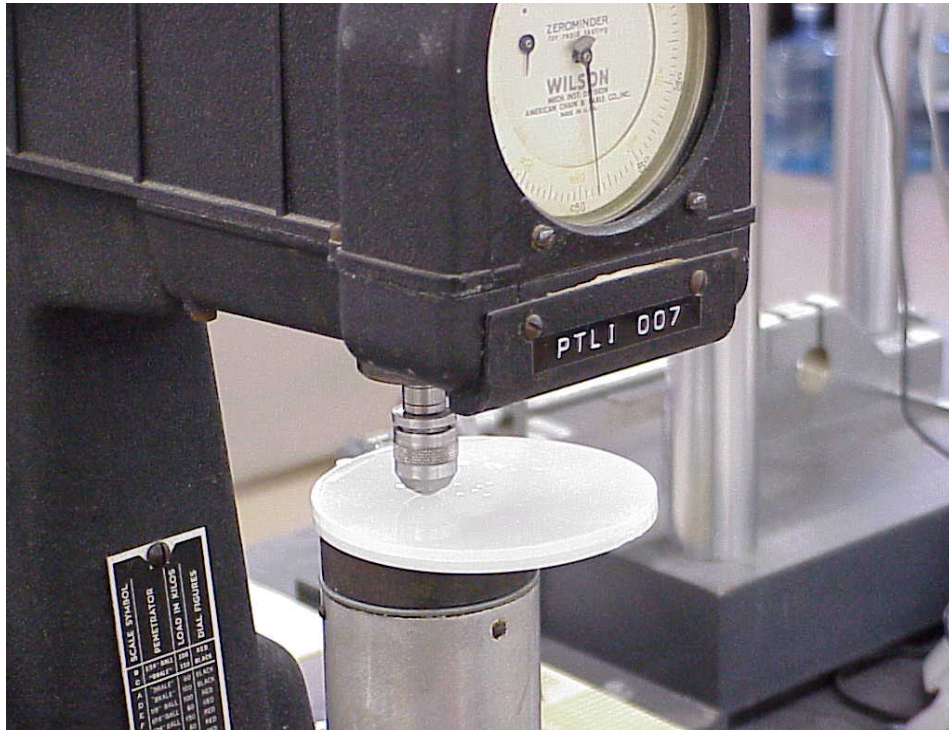
Figure 15. Wilson MIG1 Hardness Tester

Hardness testing was performed along the exposed sleeve of the sample using a Wilson MIG1 hardness tester (shown in Figure 15) calibrated for use on the Rockwell C scale. These measurements indicated a material hardness that was consistent with the 32-36 HRC range that was originally specified for the shaft. Six hardness measurements were taken at various places on the "donut" sleeve and a value of 33.5 ± 0.5 HRC was established for the material. As this hardness reading was consistent with the specifications, it helped rule out improper treatment of the material as a possible contribution to the failure of the shaft.

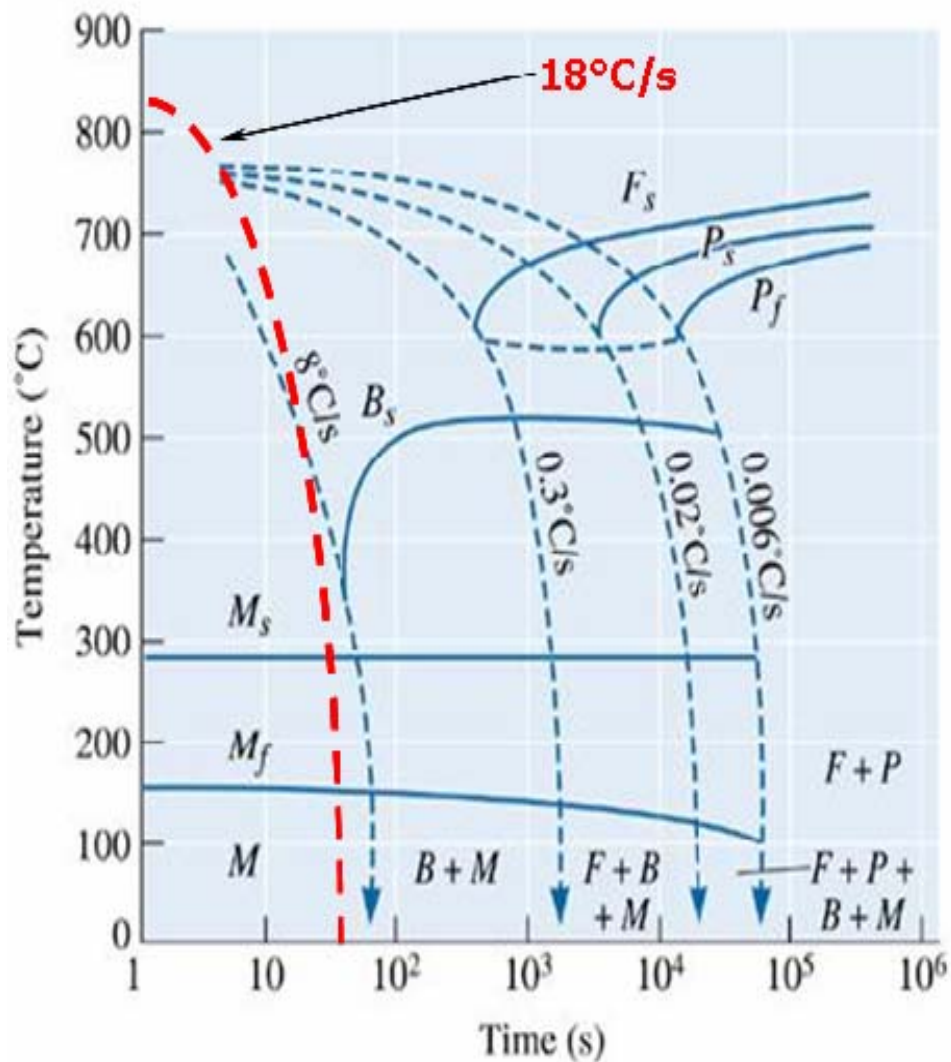
Figure 20. Continuous Cooling Transformation Curve for 4340 Steel (After Ref. 2)

From the continuous cooling transformation curve, shown in Figure 20, and using a conservative cooling rate of 18°C/s for an oil quench hollow shaft, it could be concluded that the spindle microstructure was 100% tempered martensite.

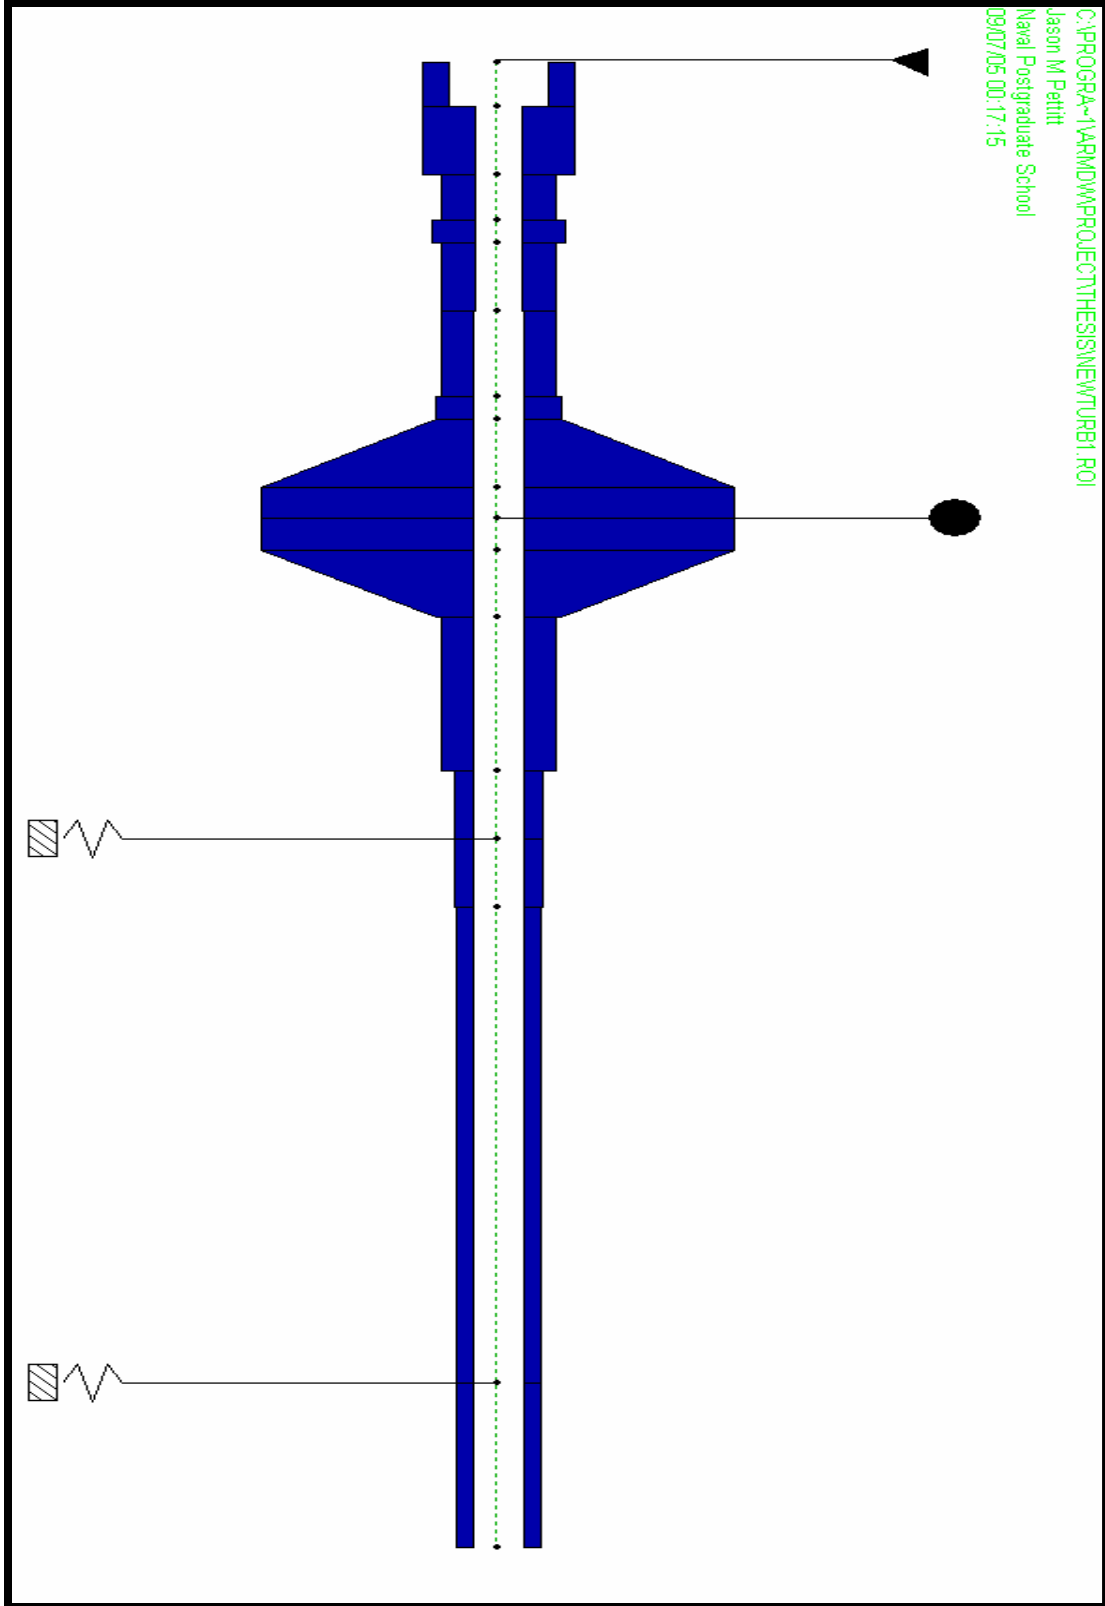
Figure 25. Turbine Wheel Branch Model

initially constructed in the rotor dynamics sub-program (Figures 25 and 26) were imported and connected at the node of connection, the rotor speed nut/turbine wheel shaft threaded connection.

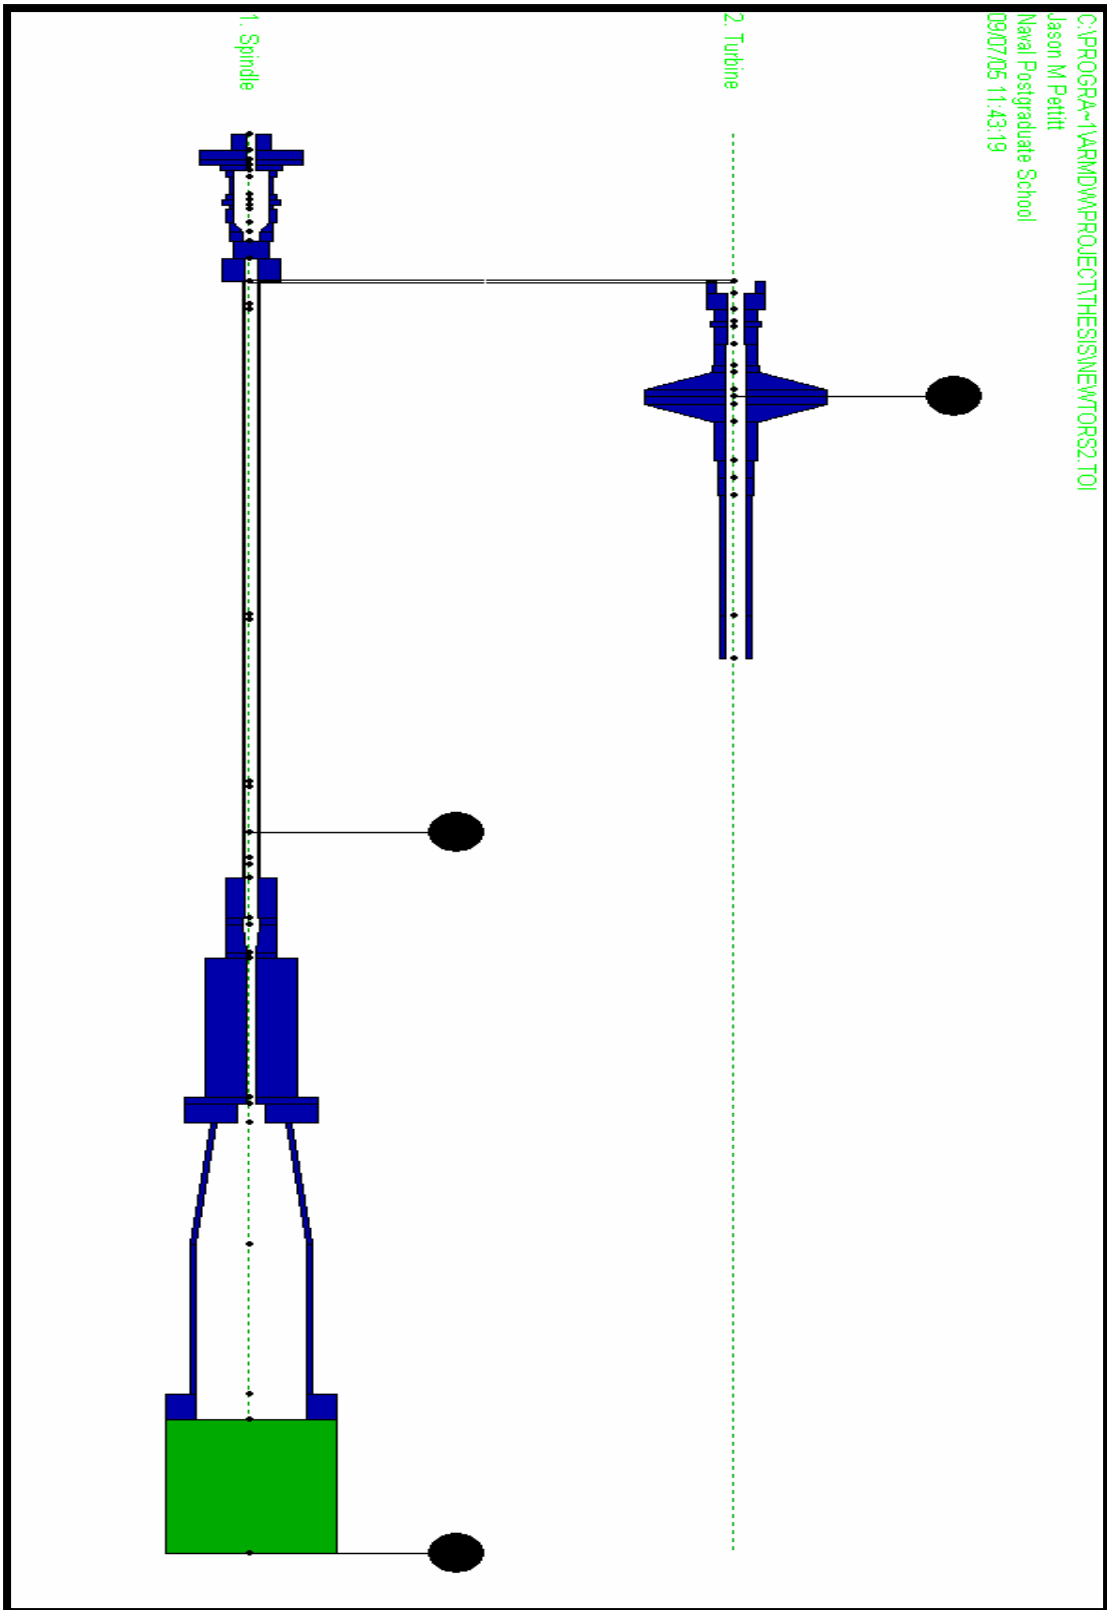
Figure 27. Torsional Vibration Model

Figure 27 shows the torsional model that was used in order to determine the natural torsional modes that were present. The torsional program in the ARMD software package allowed for the connection of the two branches from the rotor dynamics analysis. The models that were
